To repair bone height deficiency at the posterior missing tooth site of inclined alveolar crest.

- c) Diagnosis: 26 missing
d) Treatment: 26 Implant placement with simultaneous maxillary sinus floor elevation and guided bone regeneration, Conventional restoration.
e) Material:
Implant system: CAMLOG® SCREW-LINE implant, Promote® ø5.0mm, 11mm (CAMLOG®, German), bone substitute: DBBM 0.25g small particle (Bio-Oss® Gestlich, Switzerland); resorbable collagen membrane 13*25mm (Bio-Gide® , Gestlich, Switzerland).
f) Surgical procedure:
Flap elevation procedure was performed at tooth #26. Open a window in the lateral wall of the maxillary sinus, and the sinus mucoperitoneum was carefully removed under endoscopy.

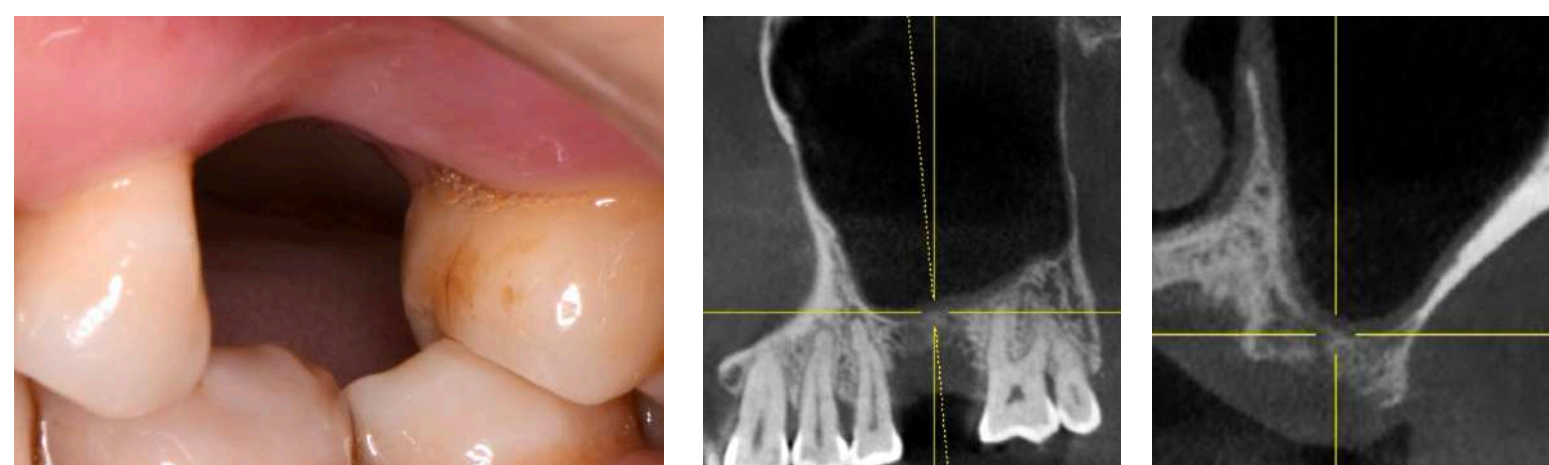
b) Examination: Tooth 26 was Missing, attached gingiva was in good condition. CBCT showed that the available bone height of 26 missing tooth sites was about 3.5mm, and the maxillary sinus floor was flat, Lingual oblique alveolar crest, low bone density.

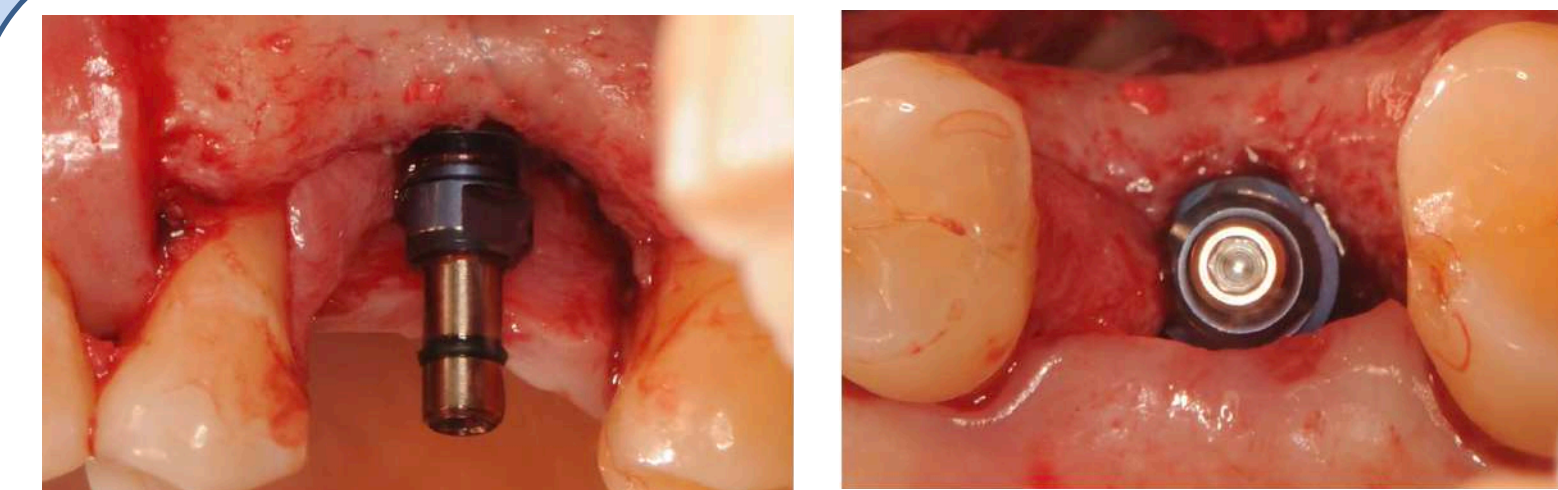
A mixture of Bio-Oss@ bone graft and autologous bone chips(8:2) was implanted into the maxillary sinus floor and on the palatal side of crest along with the dental implant.

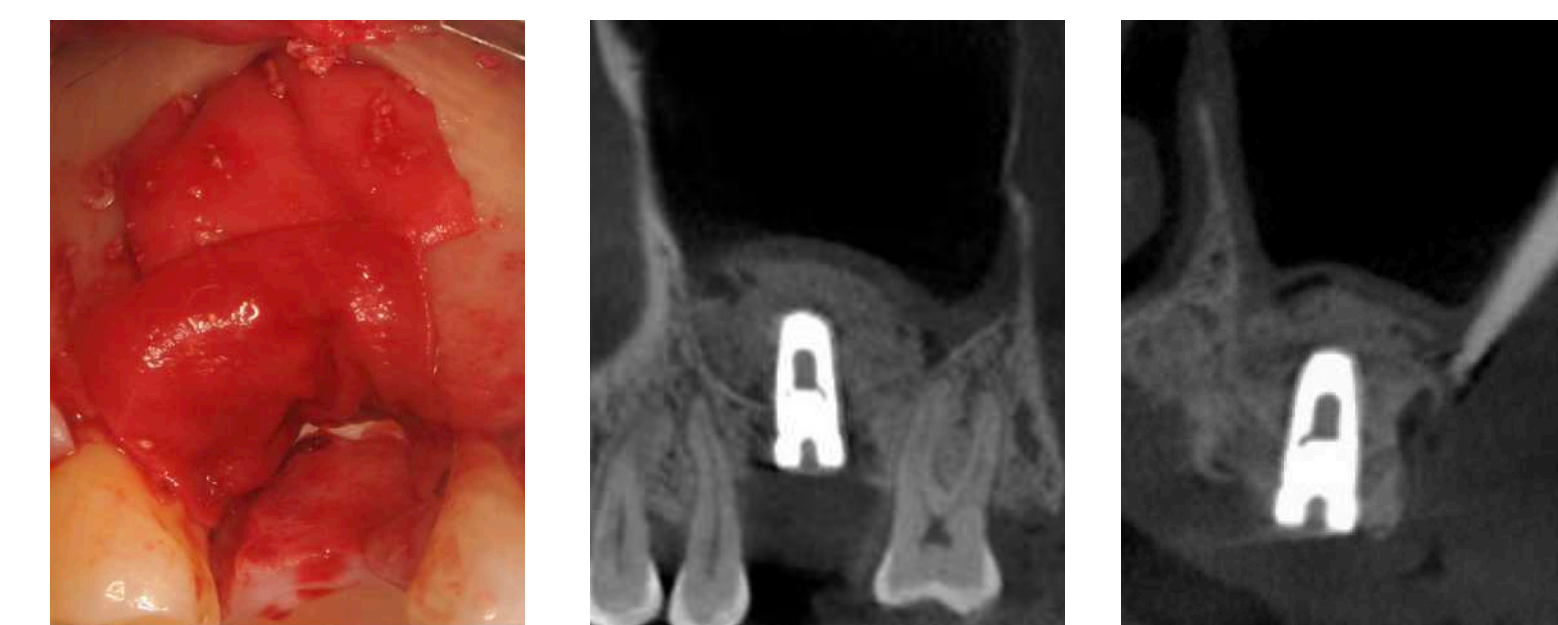
The implant was covered with a closure screw. A small amount of bone graft material was also implanted on the palatal side of the implant. The absorbable barrier membrane was then placed over the bone window and the crest of the ridge. Wound closure was performed without tension. The CBCT showed good implant position and sufficient bone augmentation volume.

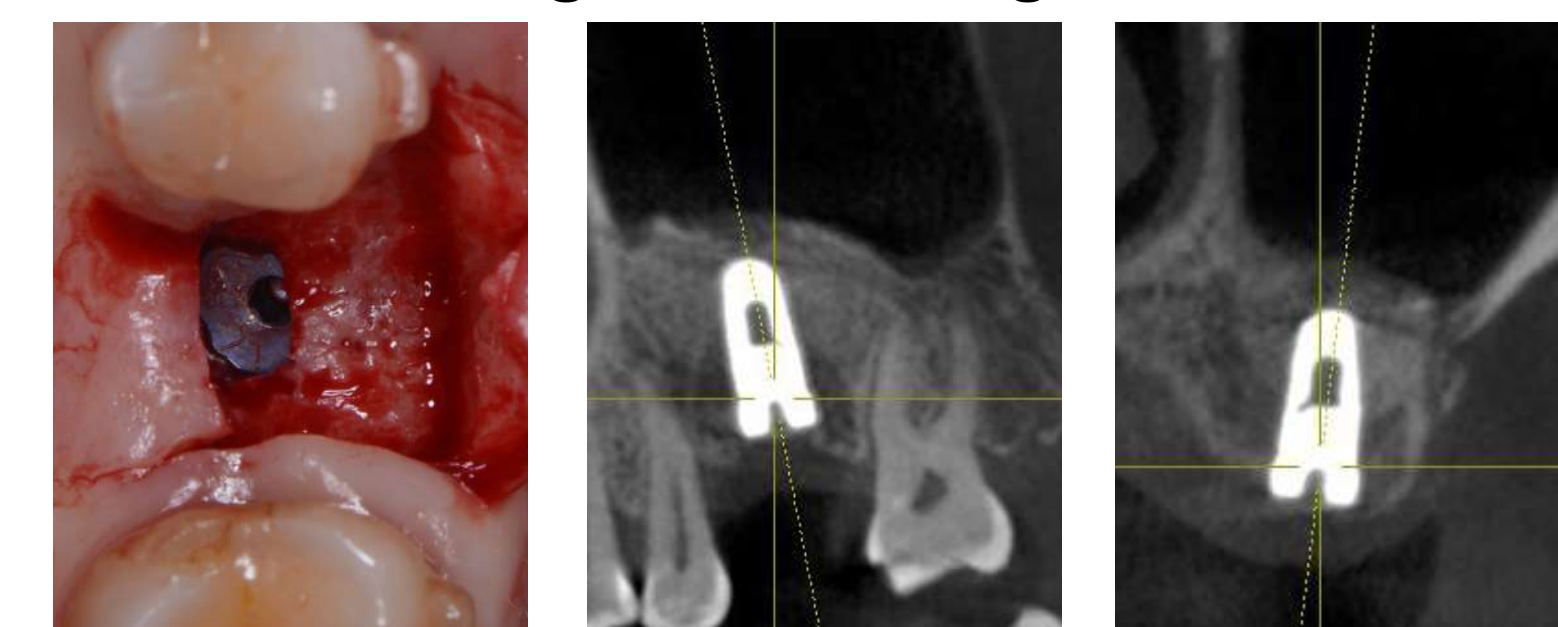
Nine months later, new bone had formed around the coronal aspect of the implant. CBCT showed good bone regeneration result.

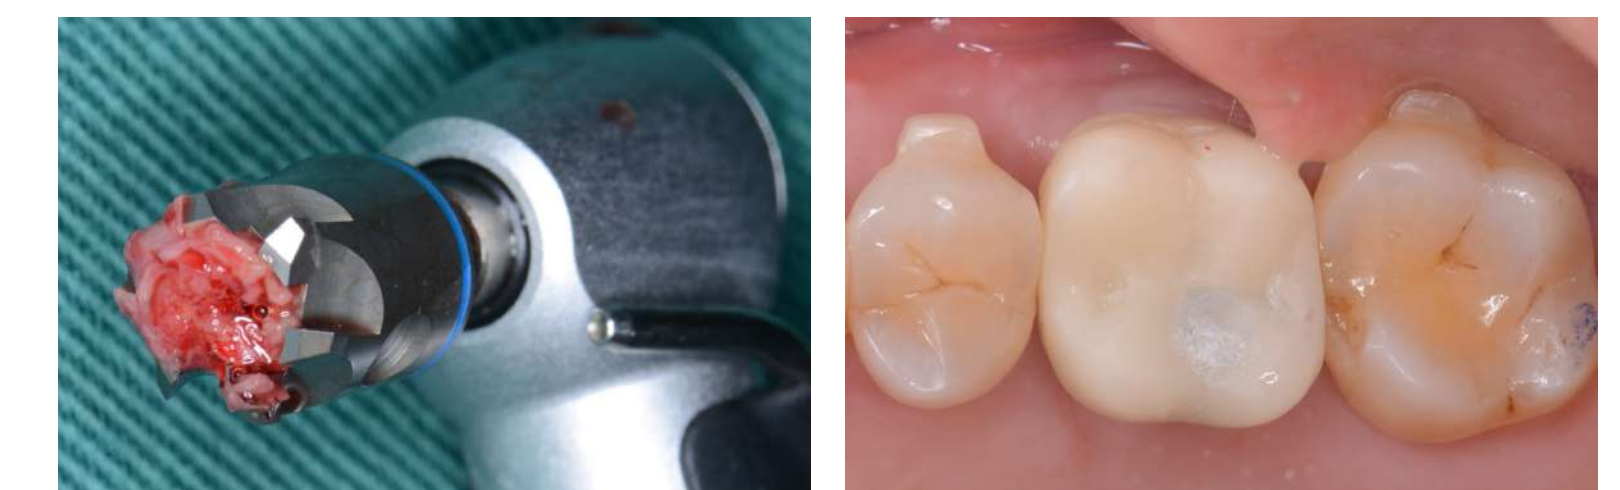
Bone profile was used to help remove the tissue and expose the Implant platform. ISQ (Implant Stability Quotient) value was 80. However, due to the patient's ongoing orthodontic treatment, a resin provisional restoration was used as an interim solution. The final restoration will be completed once the orthodontic treatment has been successfully concluded.
