## BACKGROUND

# One-piece Implant placement with simultaneous maxillary sinus floor elevation and guided bone regeneration to repair bone deficiency at the posterior missing tooth site of inclined alveolar crest: a case report

Xuemin Pi, Hong Pan, Mengjie Han, Deping Chen, Bin Ren, Xia Wang, Suxia Tang, Yucheng Su

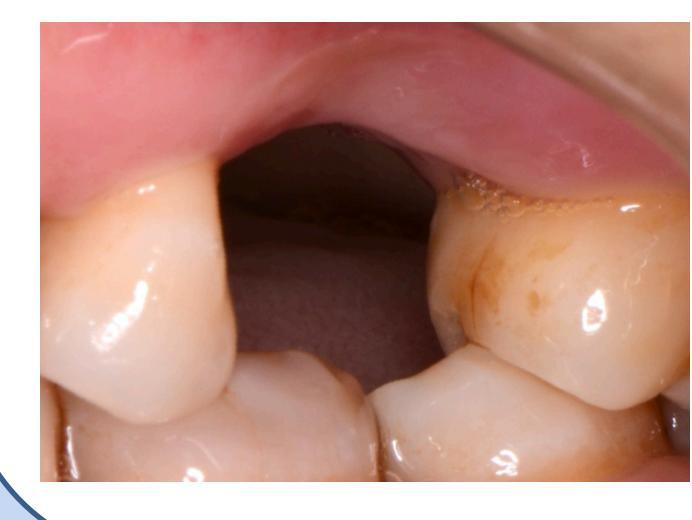
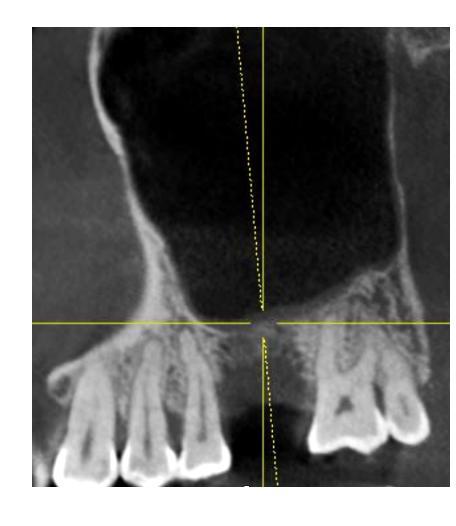
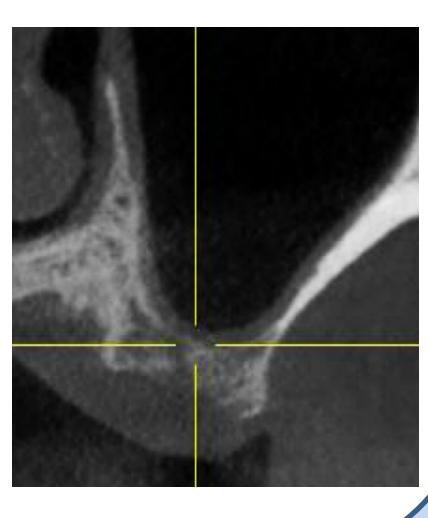
b) Examination: Tooth 26 was Missing, attached gingiva was in good condition. CBCT showed that the available bone height of 26 missing tooth sites was about 3.5mm, and the maxillary sinus floor was flat, Lingual oblique alveolar crest, low bone density.

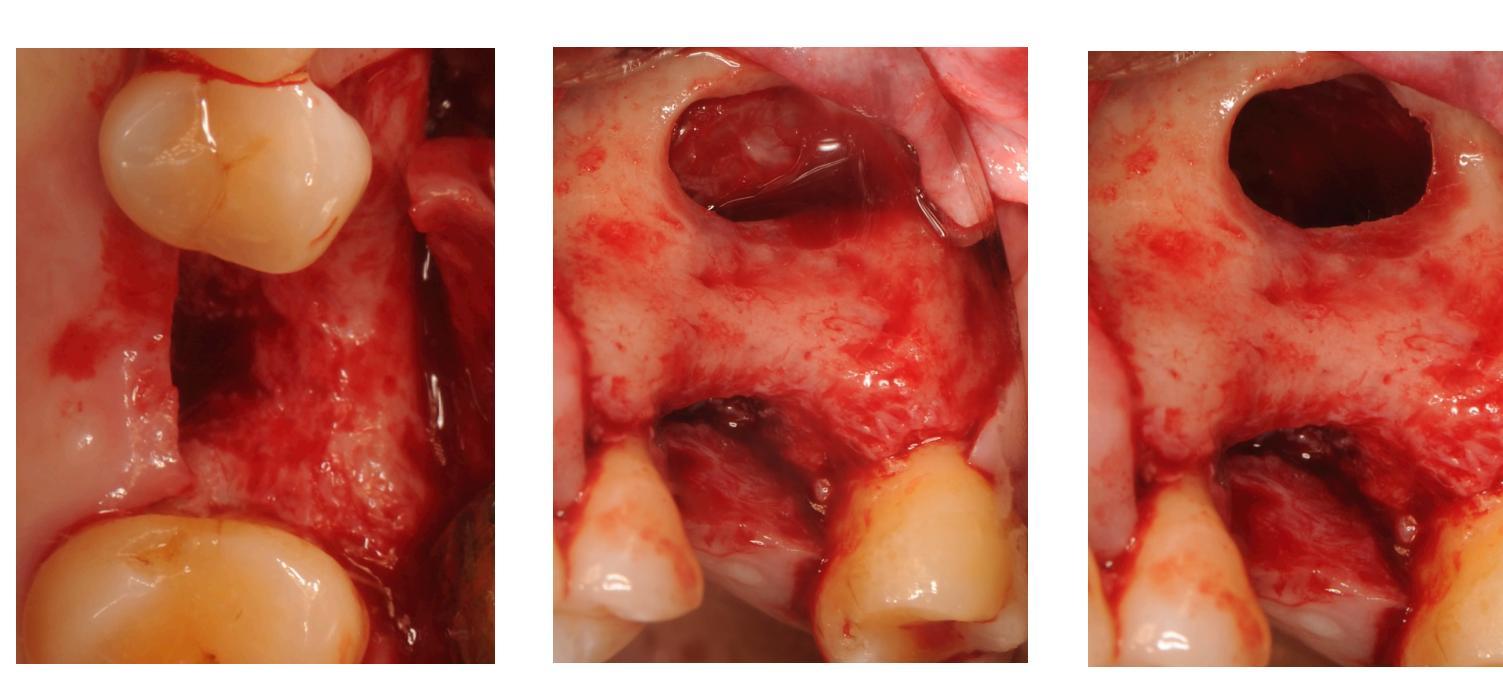
c) Diagnosis: 26 missing d) Treatment: 26 Implant placement with simultaneous maxillary sinus floor elevation and guided bone regeneration, Conventional restoration. e) Material: Implant system: CAMLOG<sup>®</sup> SCREW-LINE implant, Promote<sup>®</sup> ø5.0mm, 11mm (CAMLOG<sup>®</sup>, German), bone substitute: DBBM 0.25g small particle (Bio-Oss<sup>®</sup> Gestlich, Switzerland); resorbable collagen membrane 13\*25mm (Bio-Gide<sup>®</sup>, Gestlich, Switzerland). f) Surgical procedure: Flap elevation procedure was performed at tooth #26. Open a window in the lateral wall of the maxillary sinus, and the sinus mucoperitoneum was carefully removed under endoscopy.

A mixture of Bio-Oss@ bone graft and autologous bone chips(8:2) was implanted into the maxillary sinus floor and on the palatal side of crest along with the dental implant.

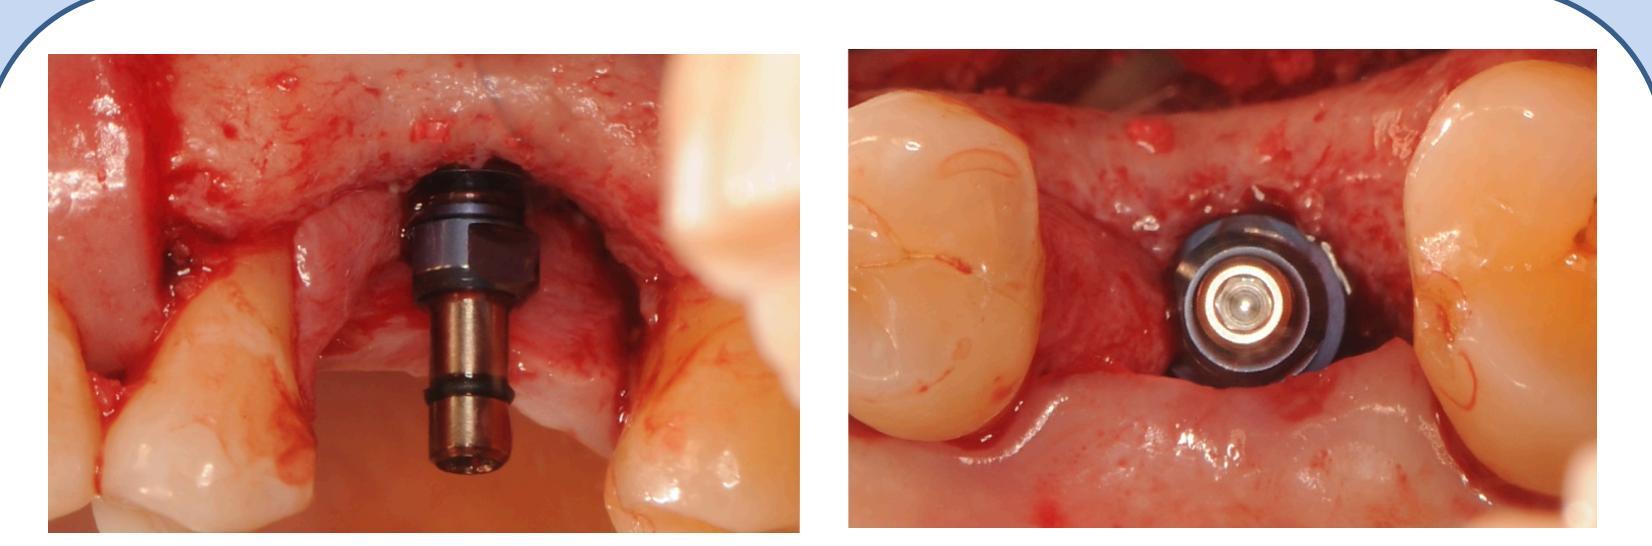
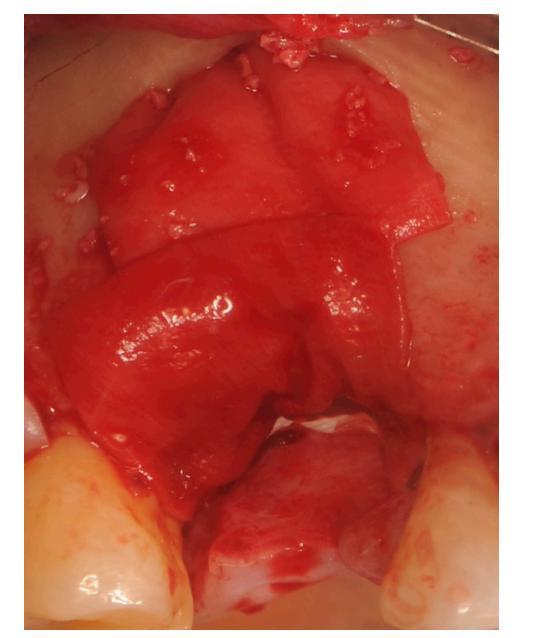
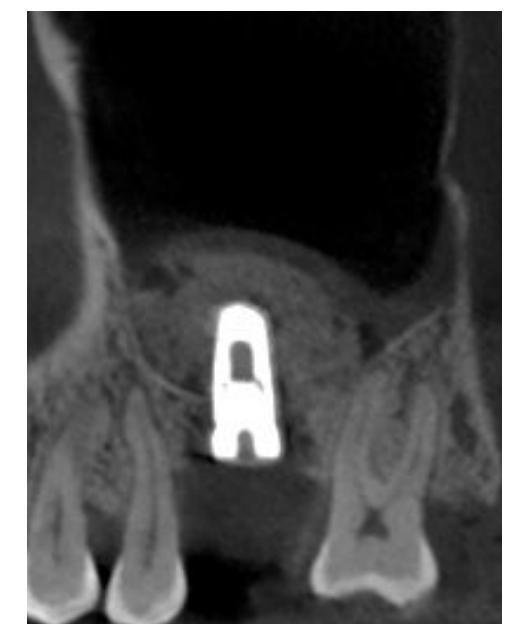
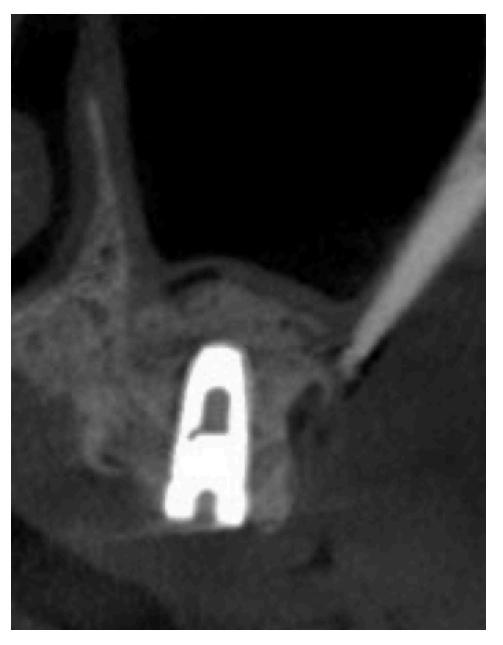
The implant was covered with a closure screw. A small amount of bone graft material was also implanted on the palatal side of the implant. The absorbable barrier membrane was then placed over the bone window and the crest of the ridge. Wound closure was performed without tension. The CBCT showed good implant position and sufficient bone augmentation volume.

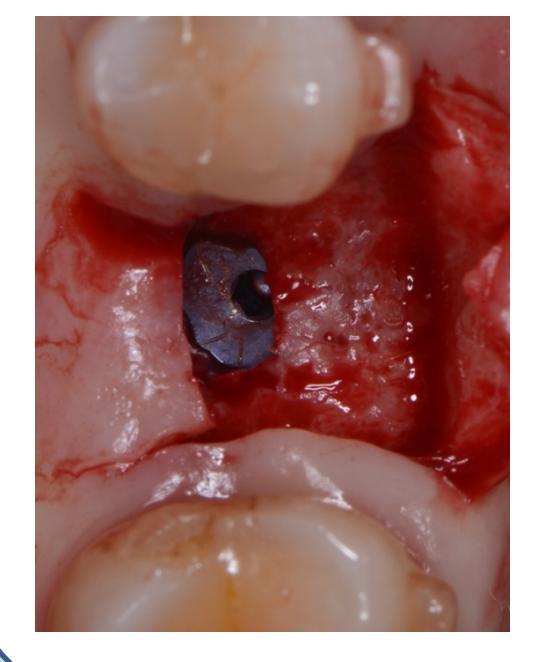
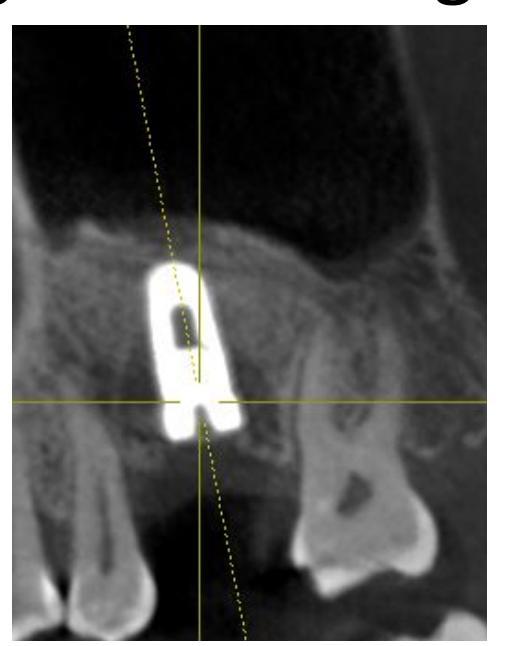
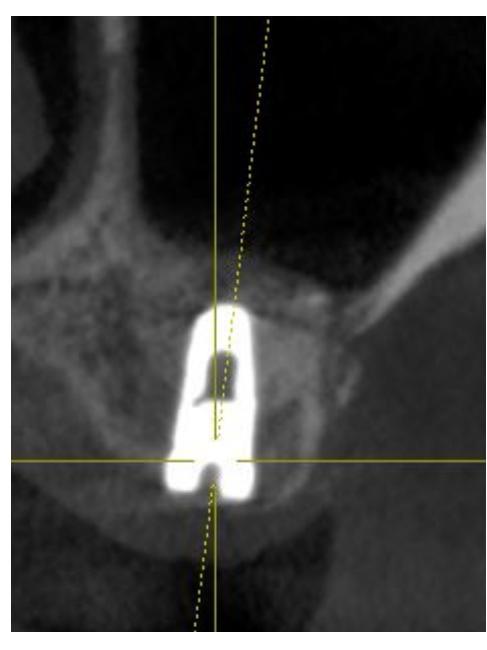
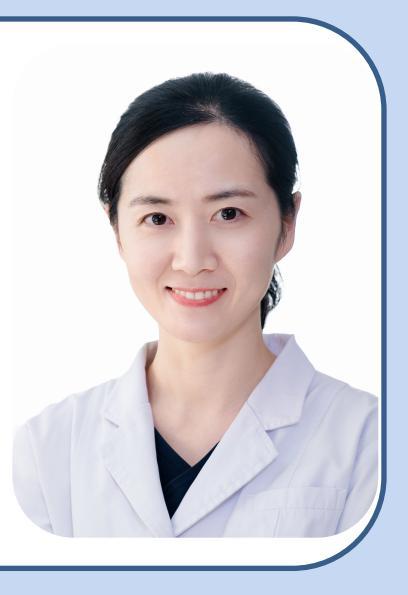
Nine months later, new bone had formed around the coronal aspect of the implant. CBCT showed good bone regeneration result.

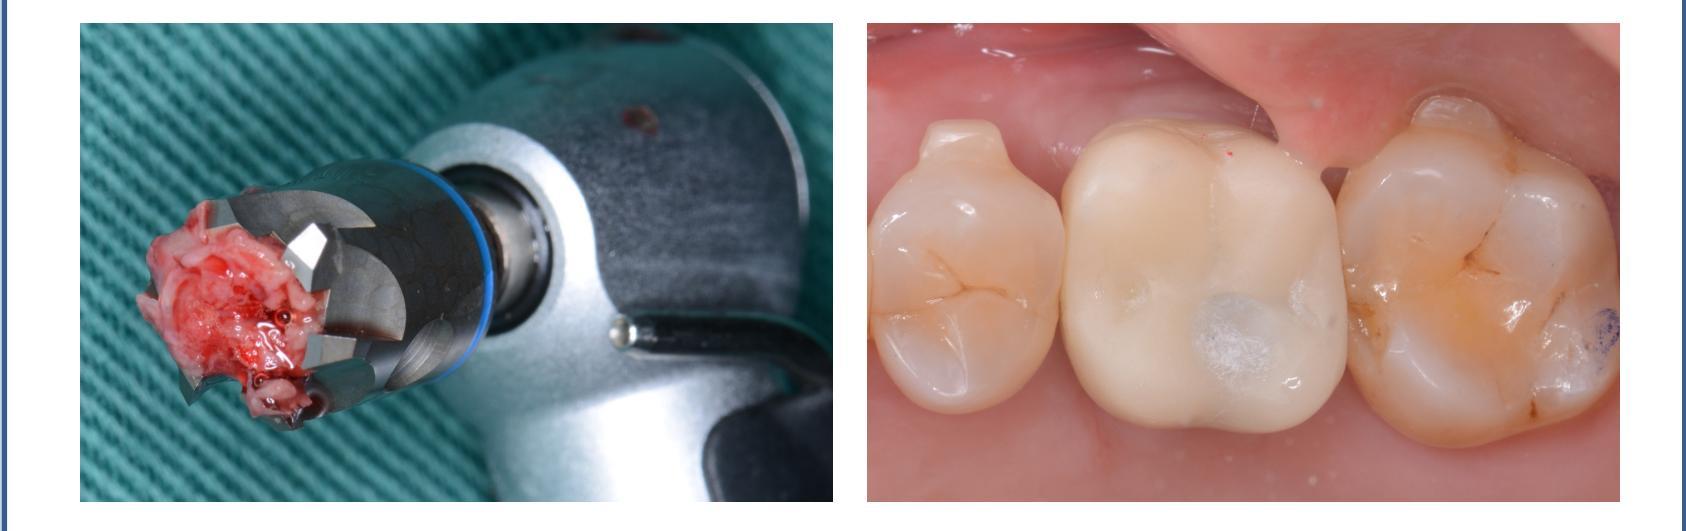
Bone profile was used to help remove the tissue and expose the Implant platform. ISQ (Implant Stability Quotient) value was 80. However, due to the patient's ongoing orthodontic treatment, a resin provisional restoration was used as an interim solution. The final restoration will be completed once the orthodontic treatment has been successfully concluded.
