# IMMEDIATE LOADING WITH CAMGUIDE IN ANTERIOR ESTHETIC ZONE WITH SOCKET GRAFTING

## Case presentation

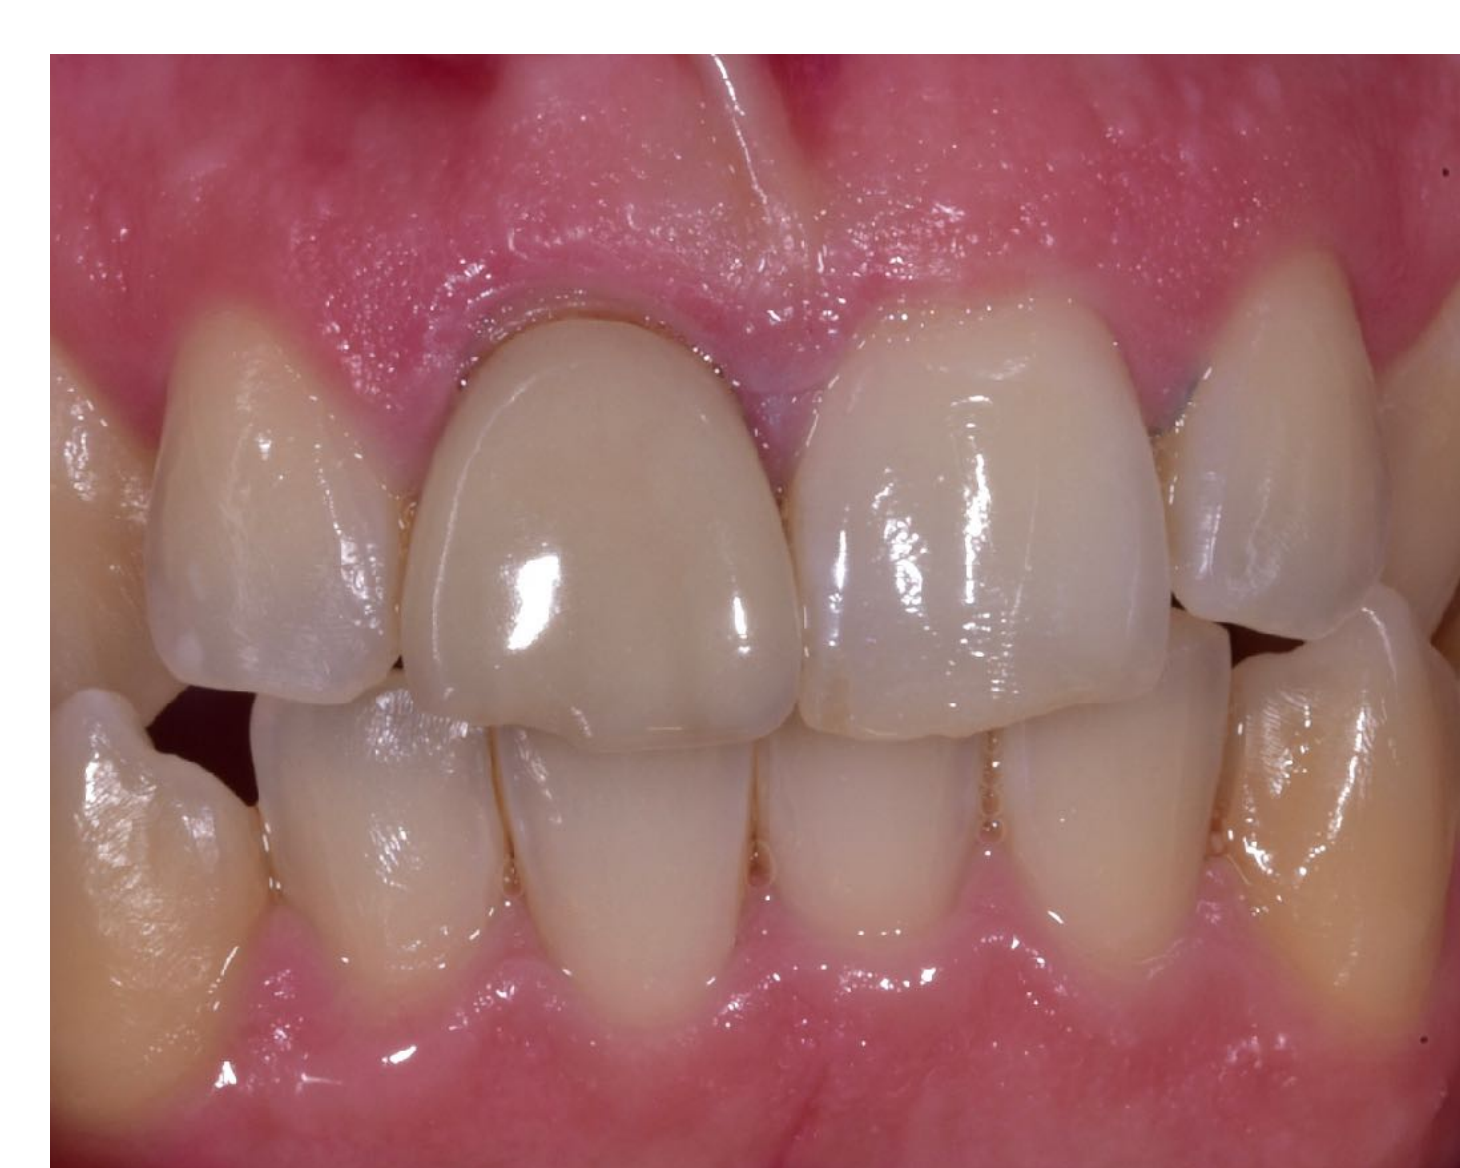
Patient came to our office regarding recurrent infection on #11. After carefull clinical and radiographical examination it is decided to extract the tooth and perform socket augmantaion procedure. Four months later implant placement is done with the help of Camguide. After the insertion of the implant, a CAD/CAM abutment over a Ti base and and a temporary crown is produced with CEREC. 4 months later temporary restoration is replaced with a definitive CAD/CAM e-max crown.
